# Selling Arguments *for* TIN ROOFING

*A review of the advantages of  
roofs of this type*

A textbook containing corrected tables for use in estimating, instructions for laying tin roofs, description of the manufacture of roofing tin, and a large amount of information useful to the practical man.

N. & G. Taylor Company, Philadelphia

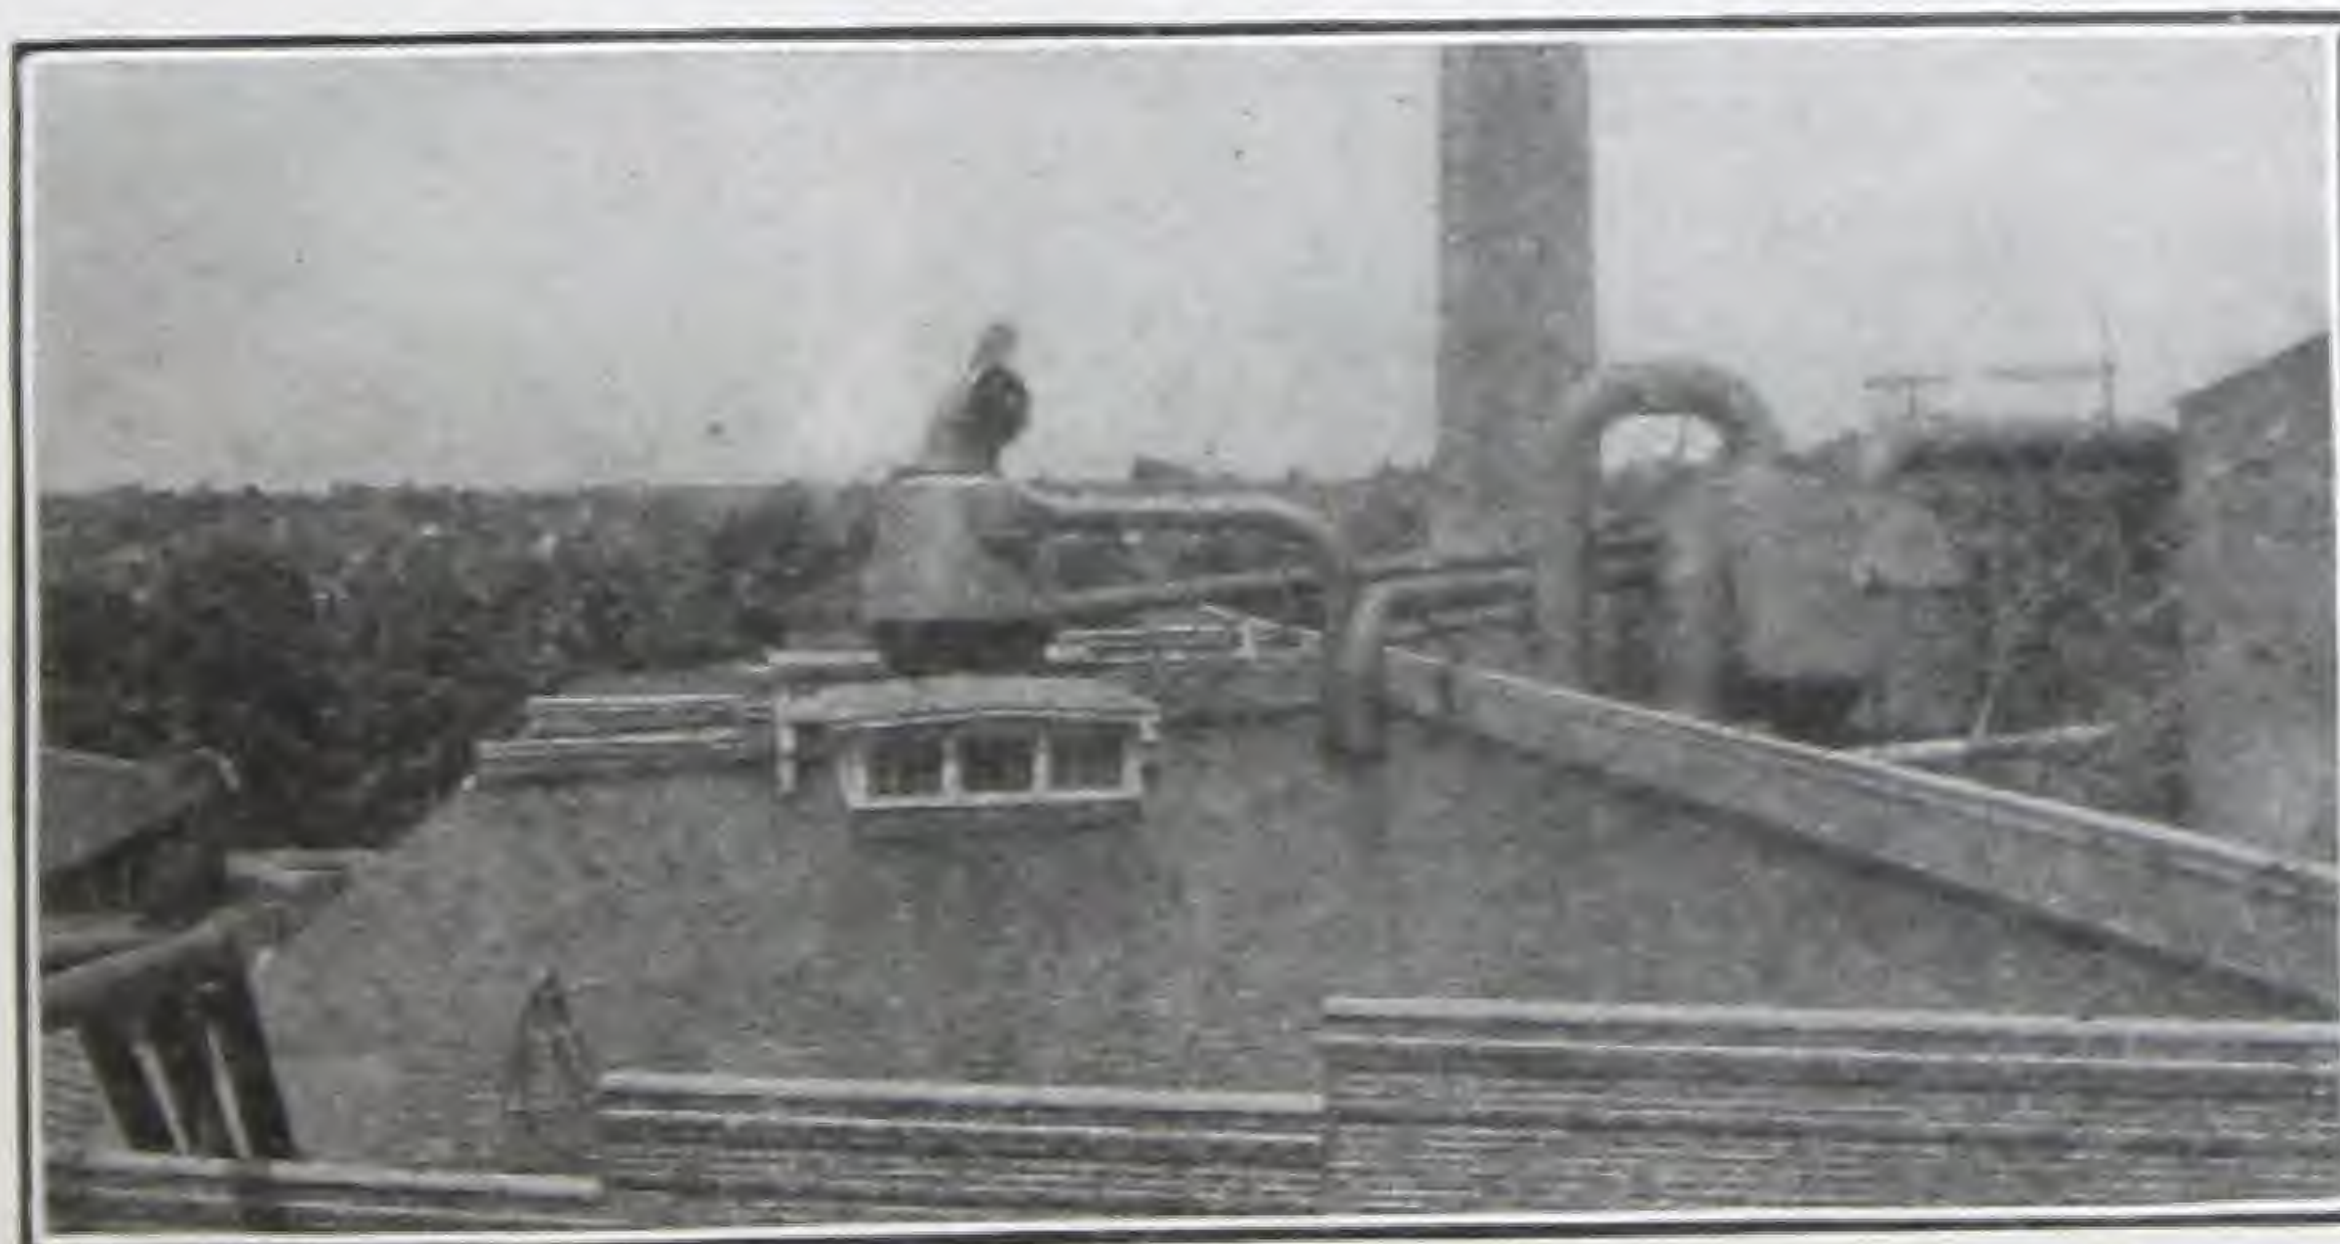
**46. GOOD TIN REPLACES TAR-AND-GRAVEL ROOFS:** Roof view, American Pad & Textile Co. buildings, Greenfield, Ohio. In 1909, Target-and-Arrow tin was used on these buildings to replace tar-and-gravel roofs, which had proved unsatisfactory. The owners write us that they are well pleased with the clean, handsome appearance of the tin roofs as compared with the dirty, unsightly tar and gravel, and they have adopted good tin as a standard for use on their buildings. They say: "We consider good tin roofs far superior to any of the so-called composition roofings."

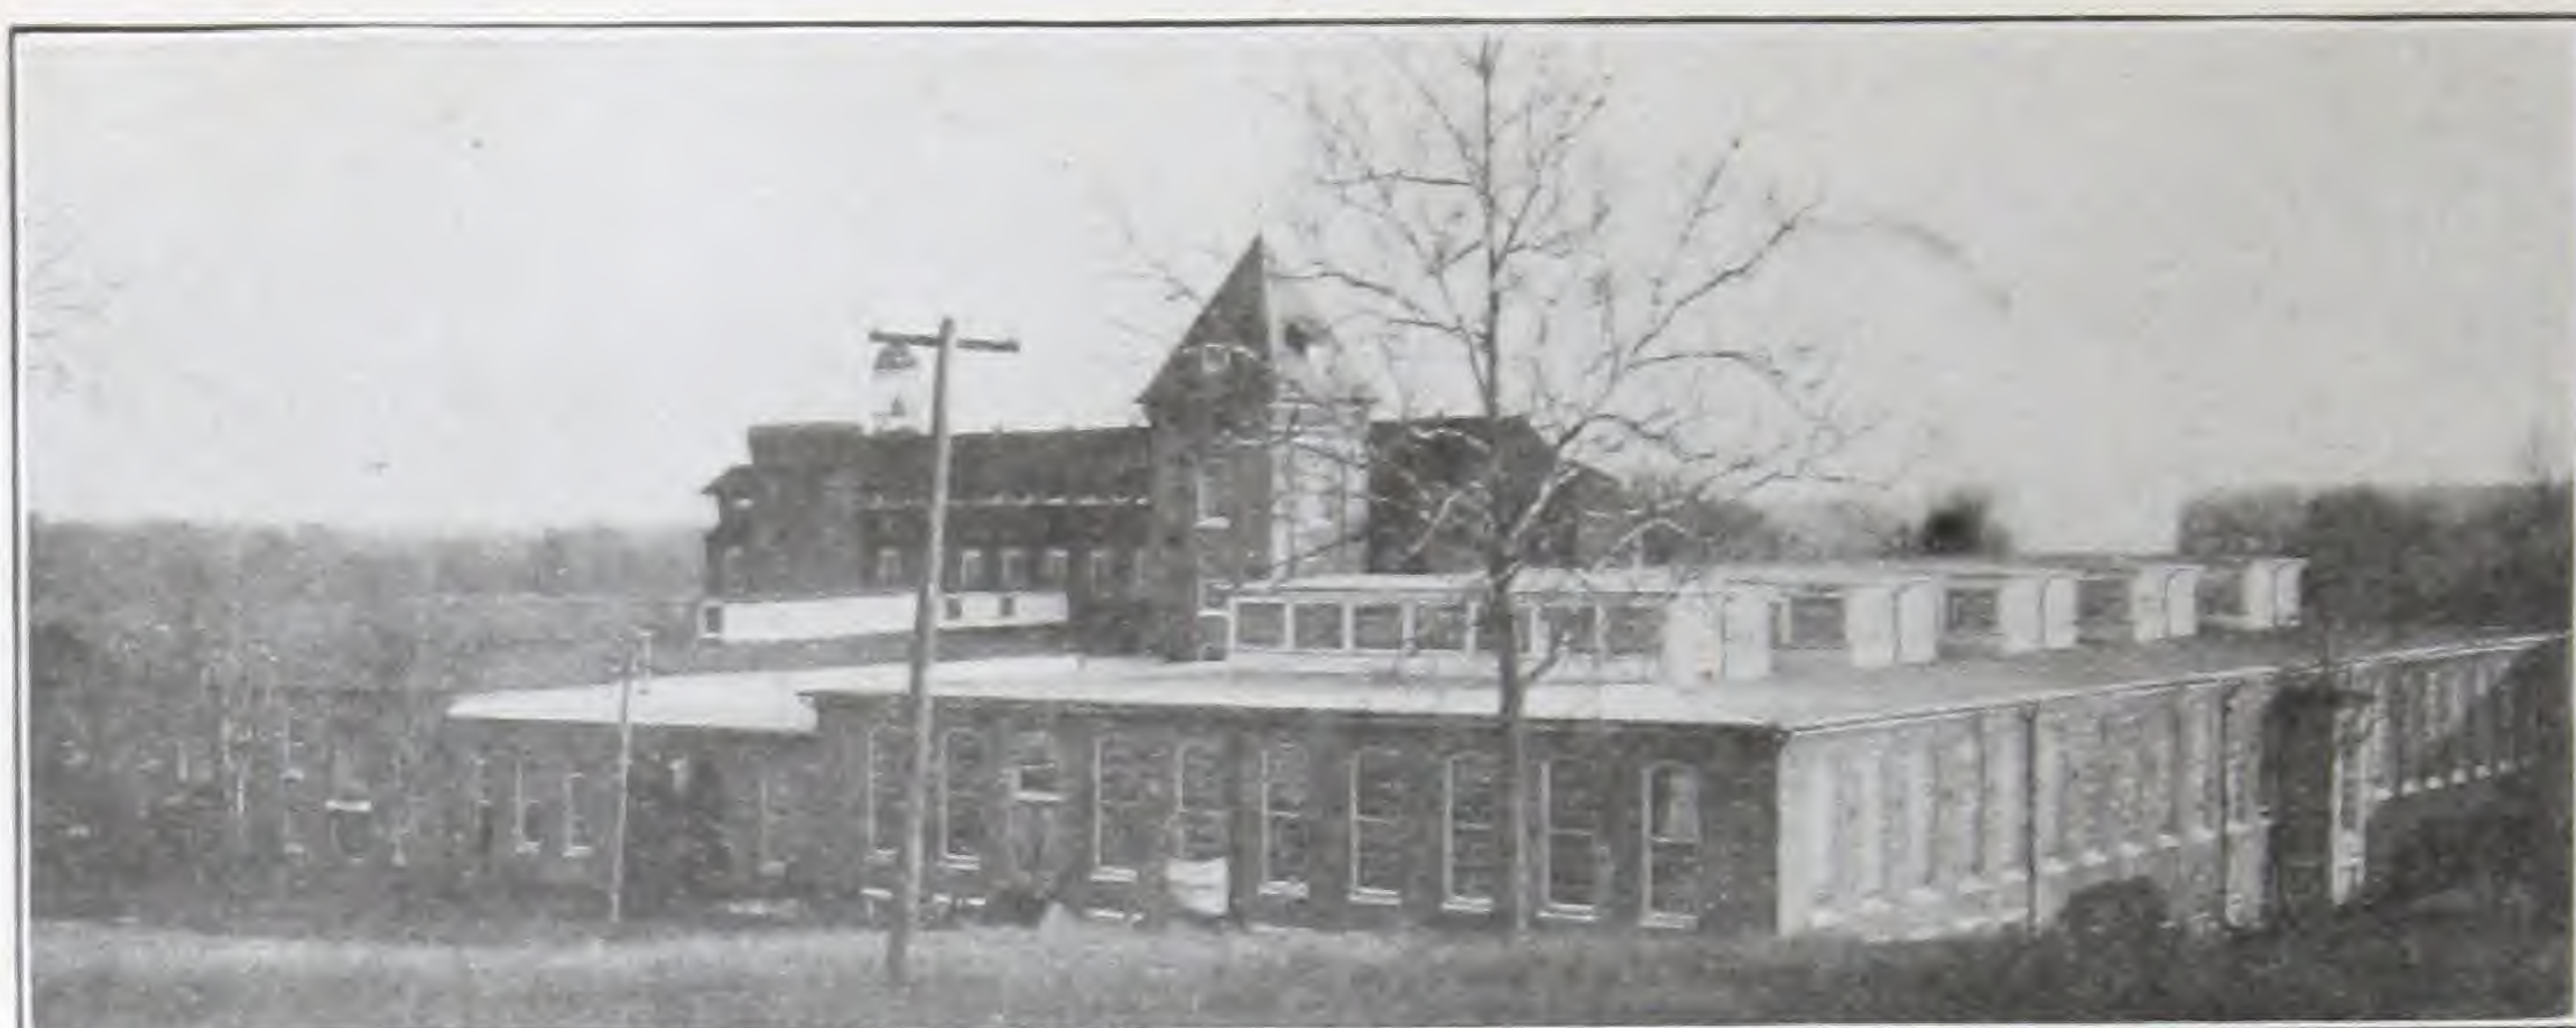
**47. NOTABLE TIN-ROOFING CONTRACTS:** The Savage Manufacturing Co.'s mill, near Baltimore, Md., roofed in 1909 with 65 boxes of good, heavily coated roofing tin, our Target-and-Arrow brand. Charles A. Hicks, roofer. The largest roofing job laid in this part of the country for some time.

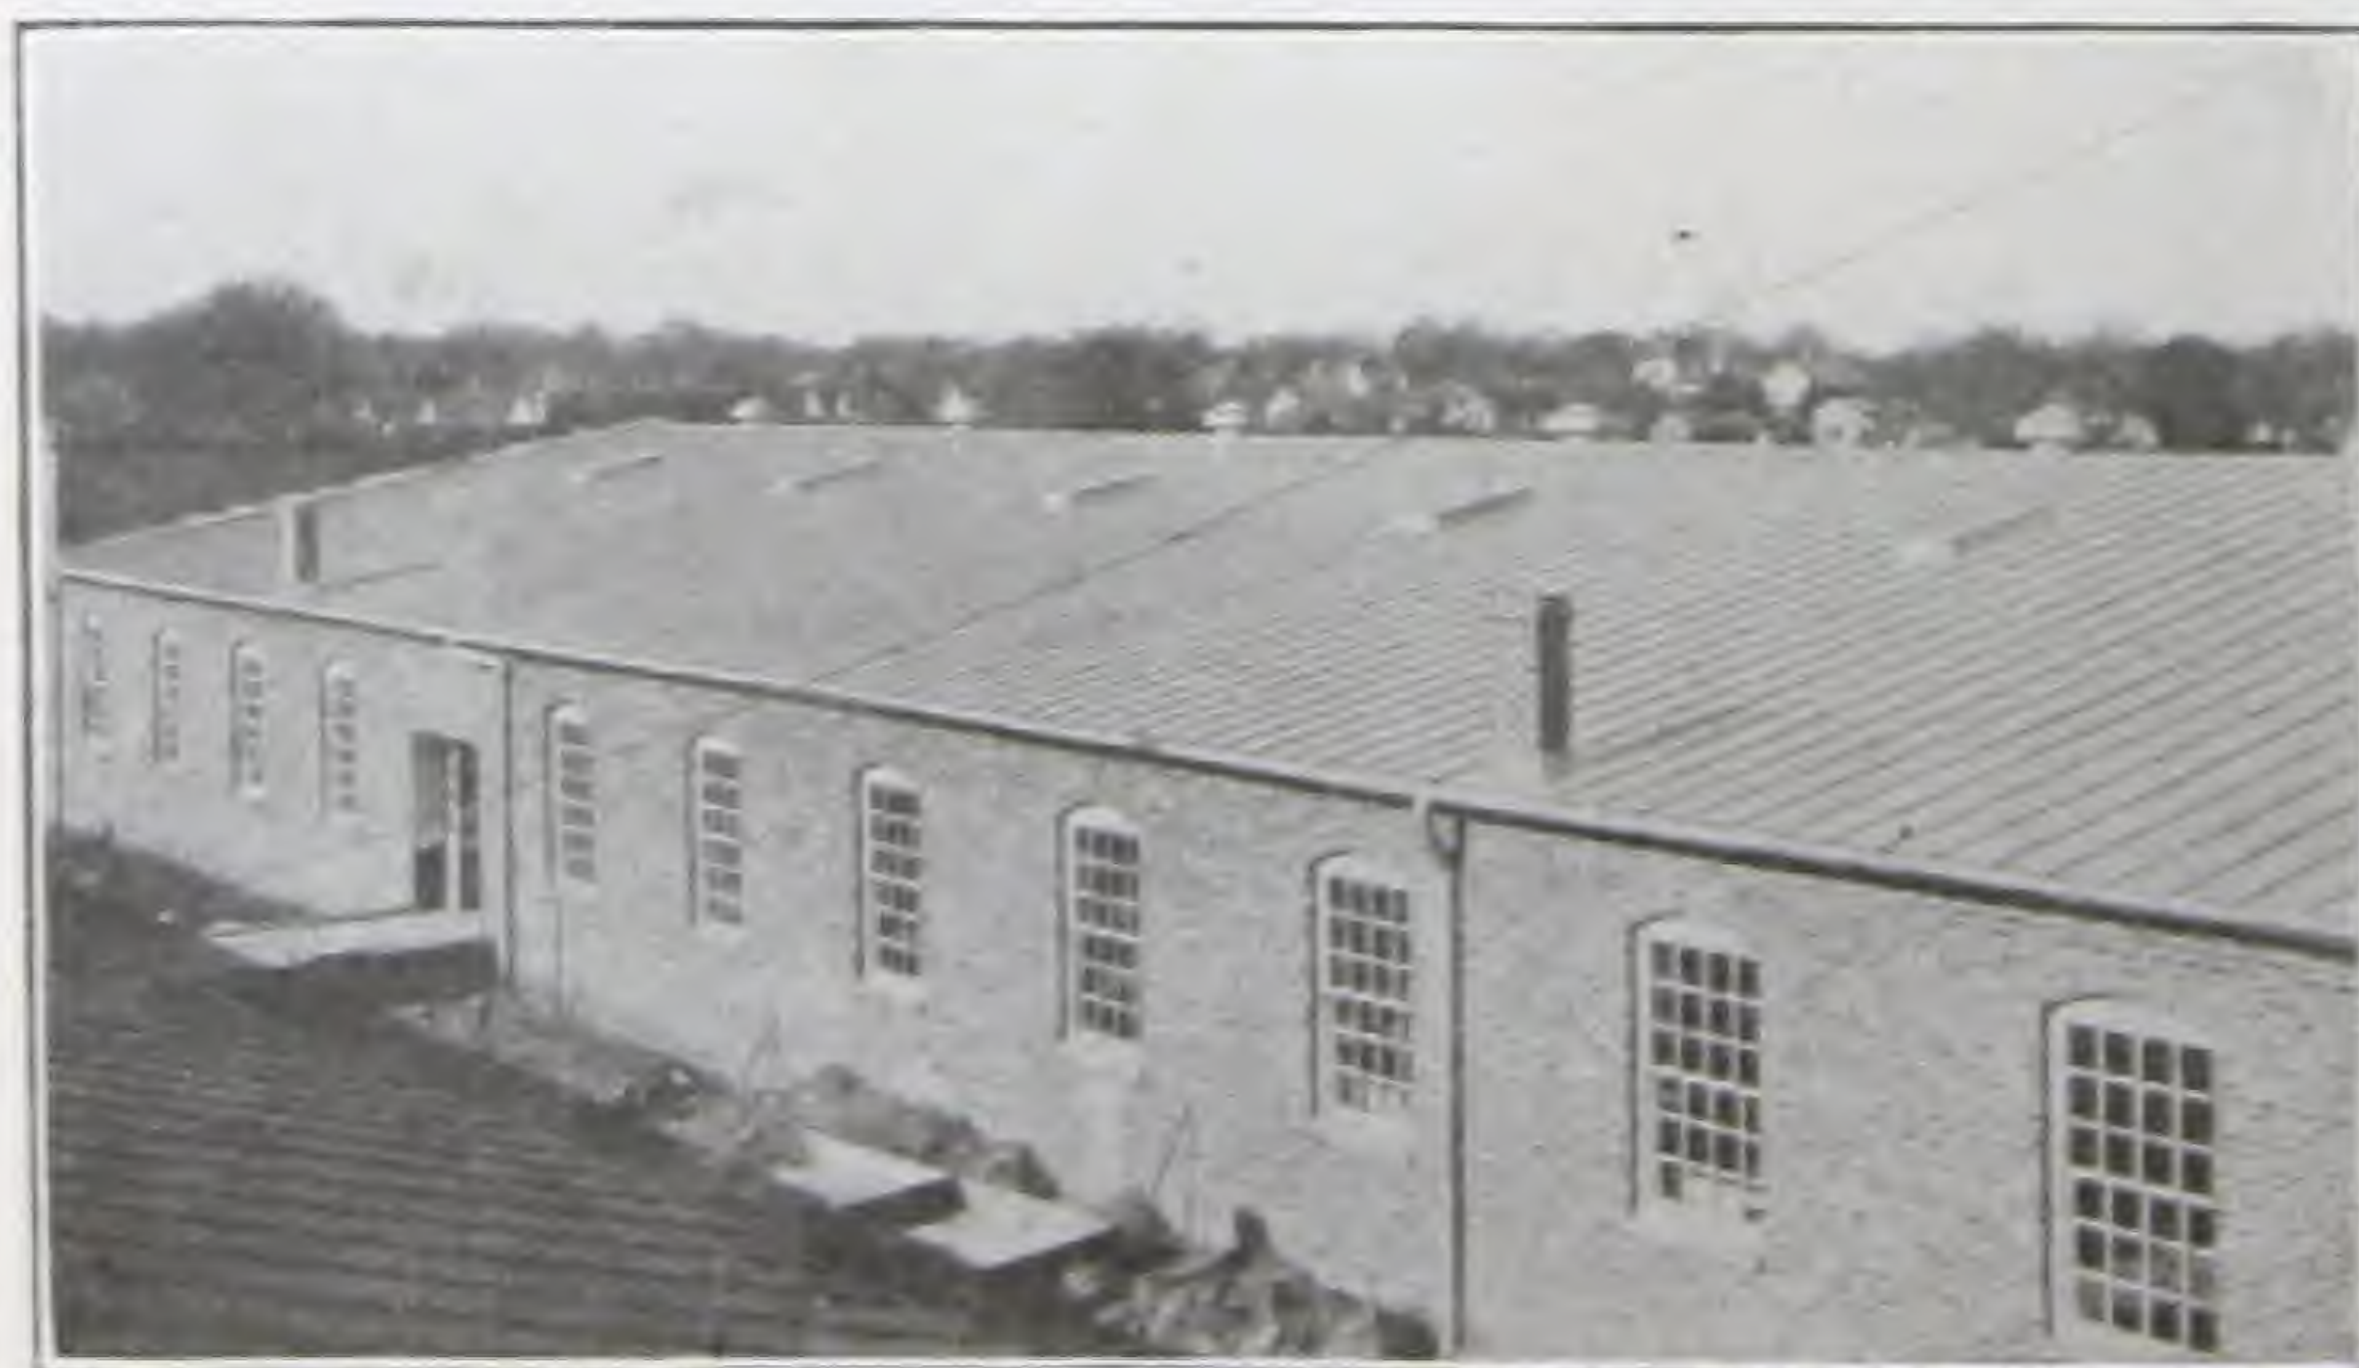
**48. NOTABLE TIN-ROOFING CONTRACTS:** Good roofing tin was used to cover the new factory building of the Hackney Wagon Co. at Wilson, N. C., in 1909. Forty boxes of Target-and-Arrow tin required. Work done by R. E. Hagan, roofer, Wilson, N. C.

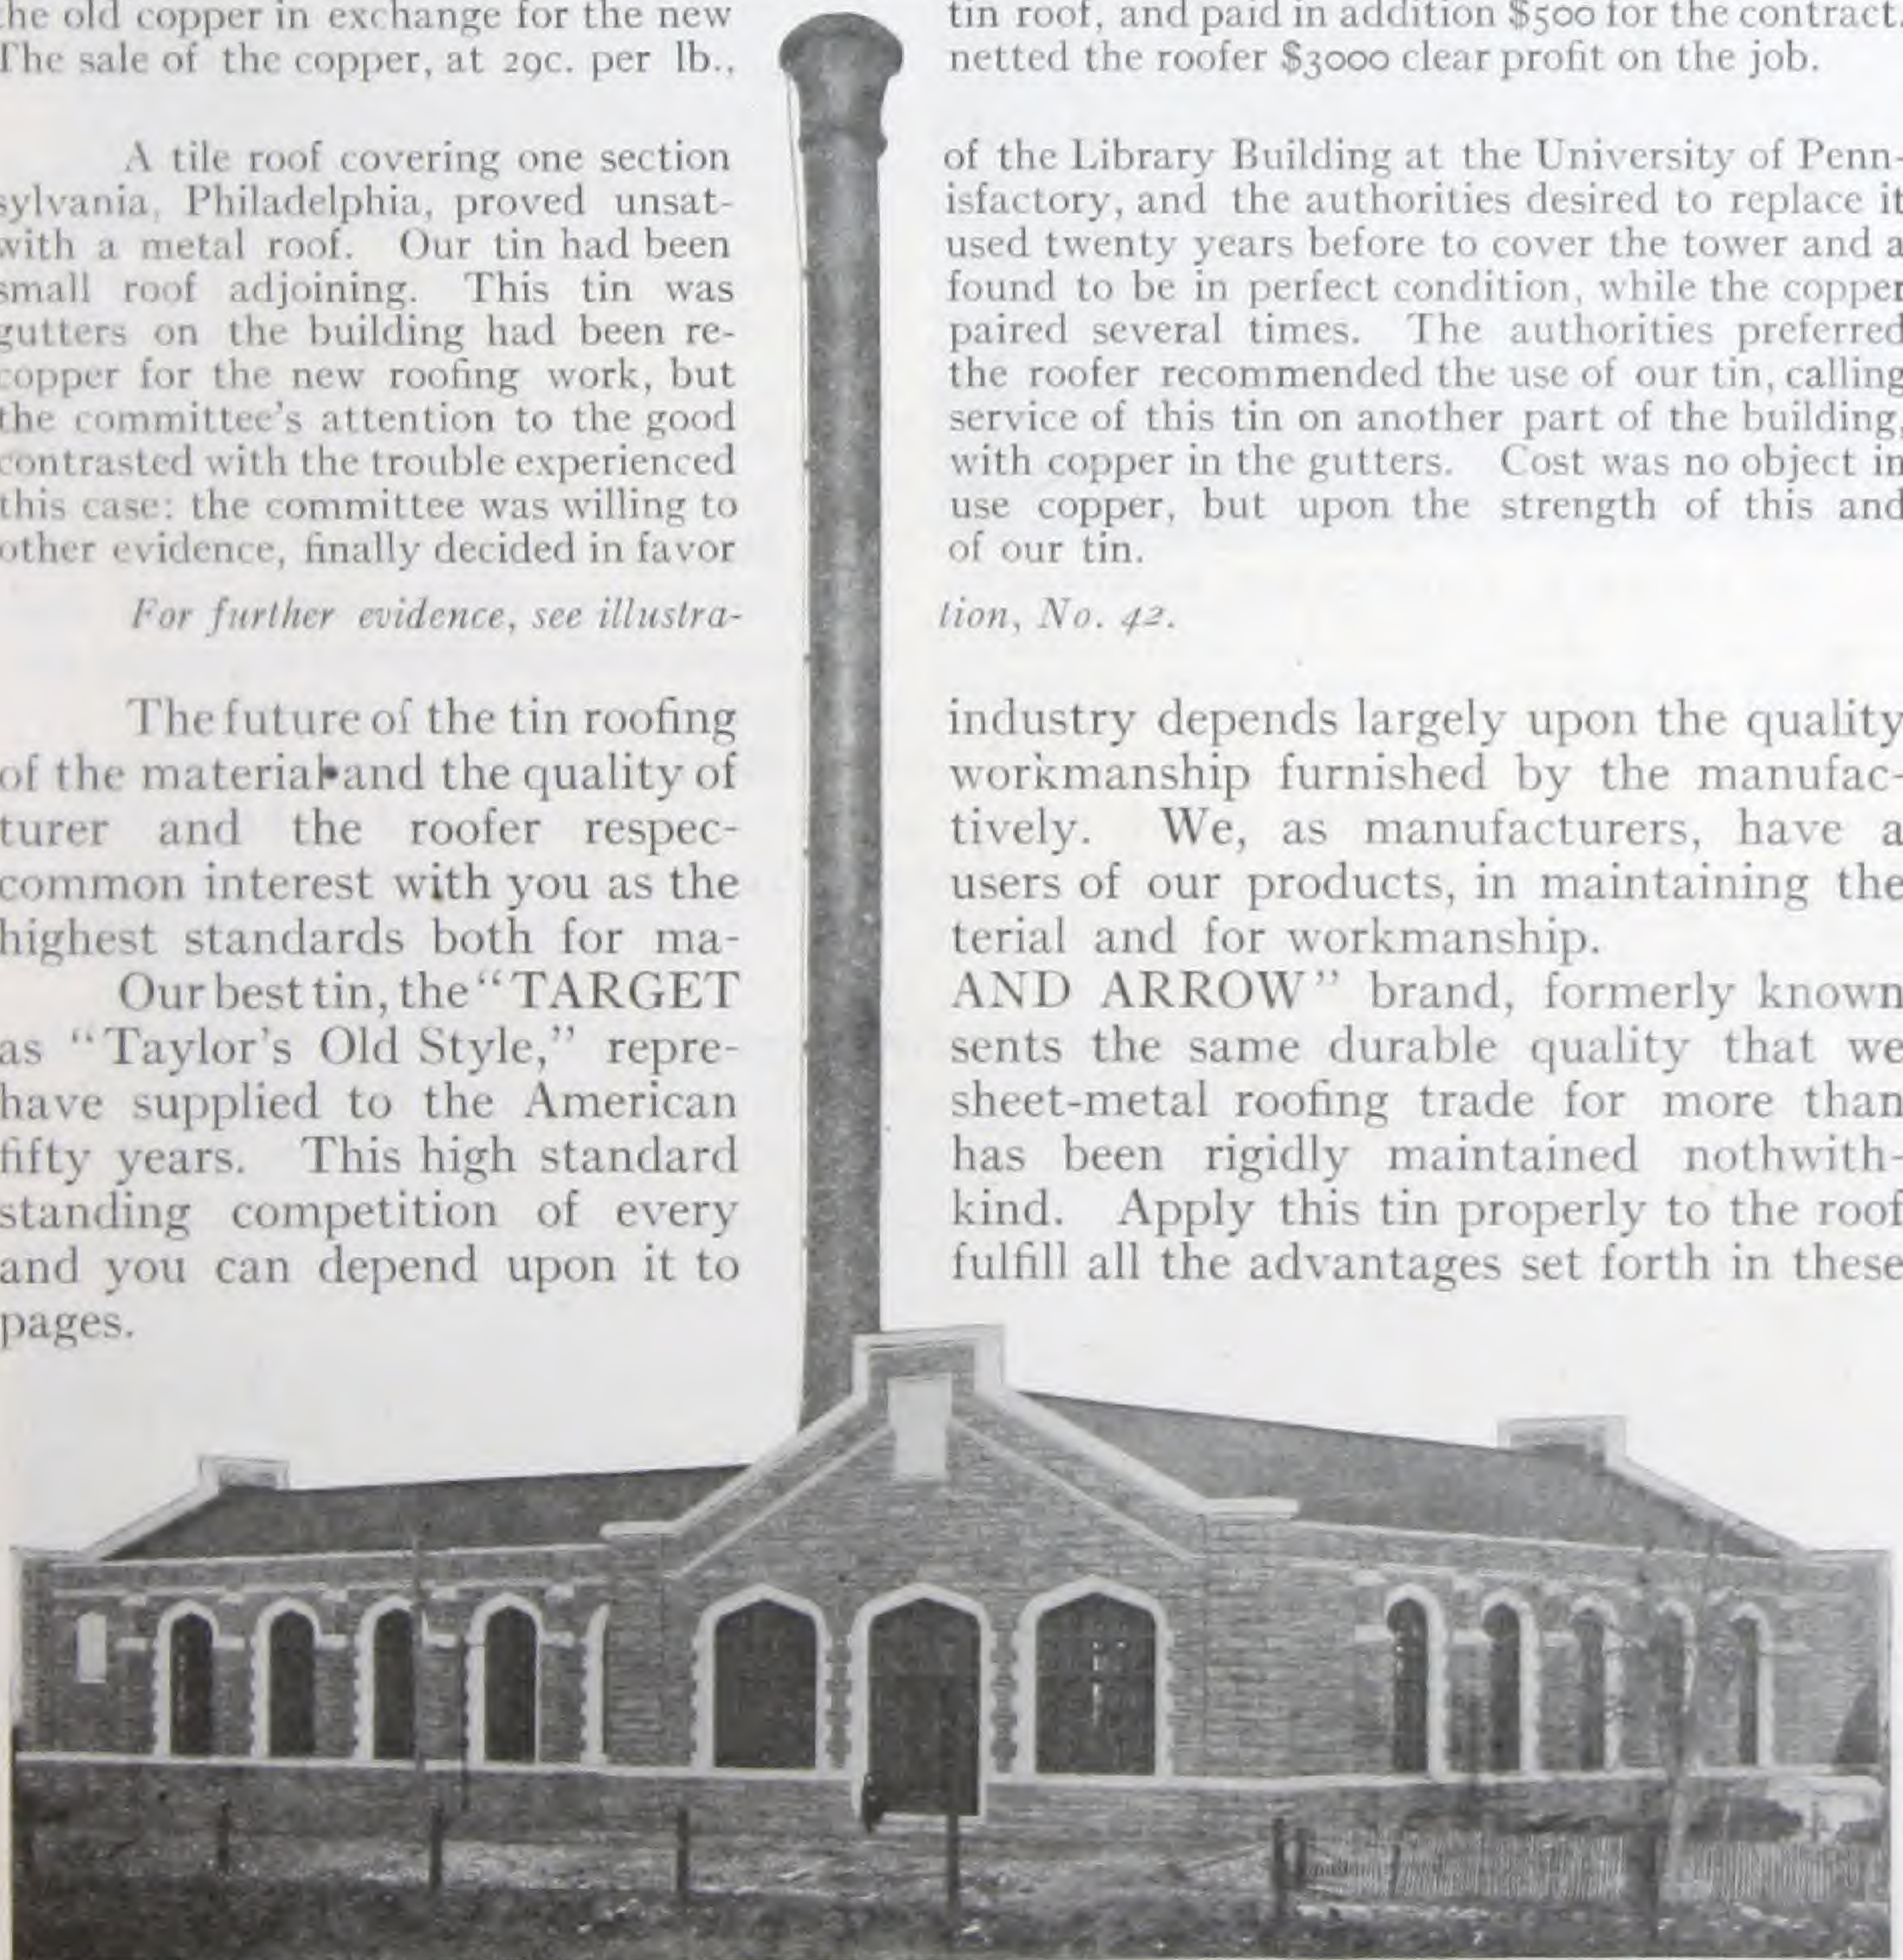
**49. NOTABLE TIN-ROOFING CONTRACTS:** Power plant, University of Colorado, Boulder, Colo. Gove & Walsh, architects, Denver, Colo. Roofed with 100 squares Target-and-Arrow tin laid standing-seam. A fine example of the use of high-grade roofing material for a first-class, substantial building.

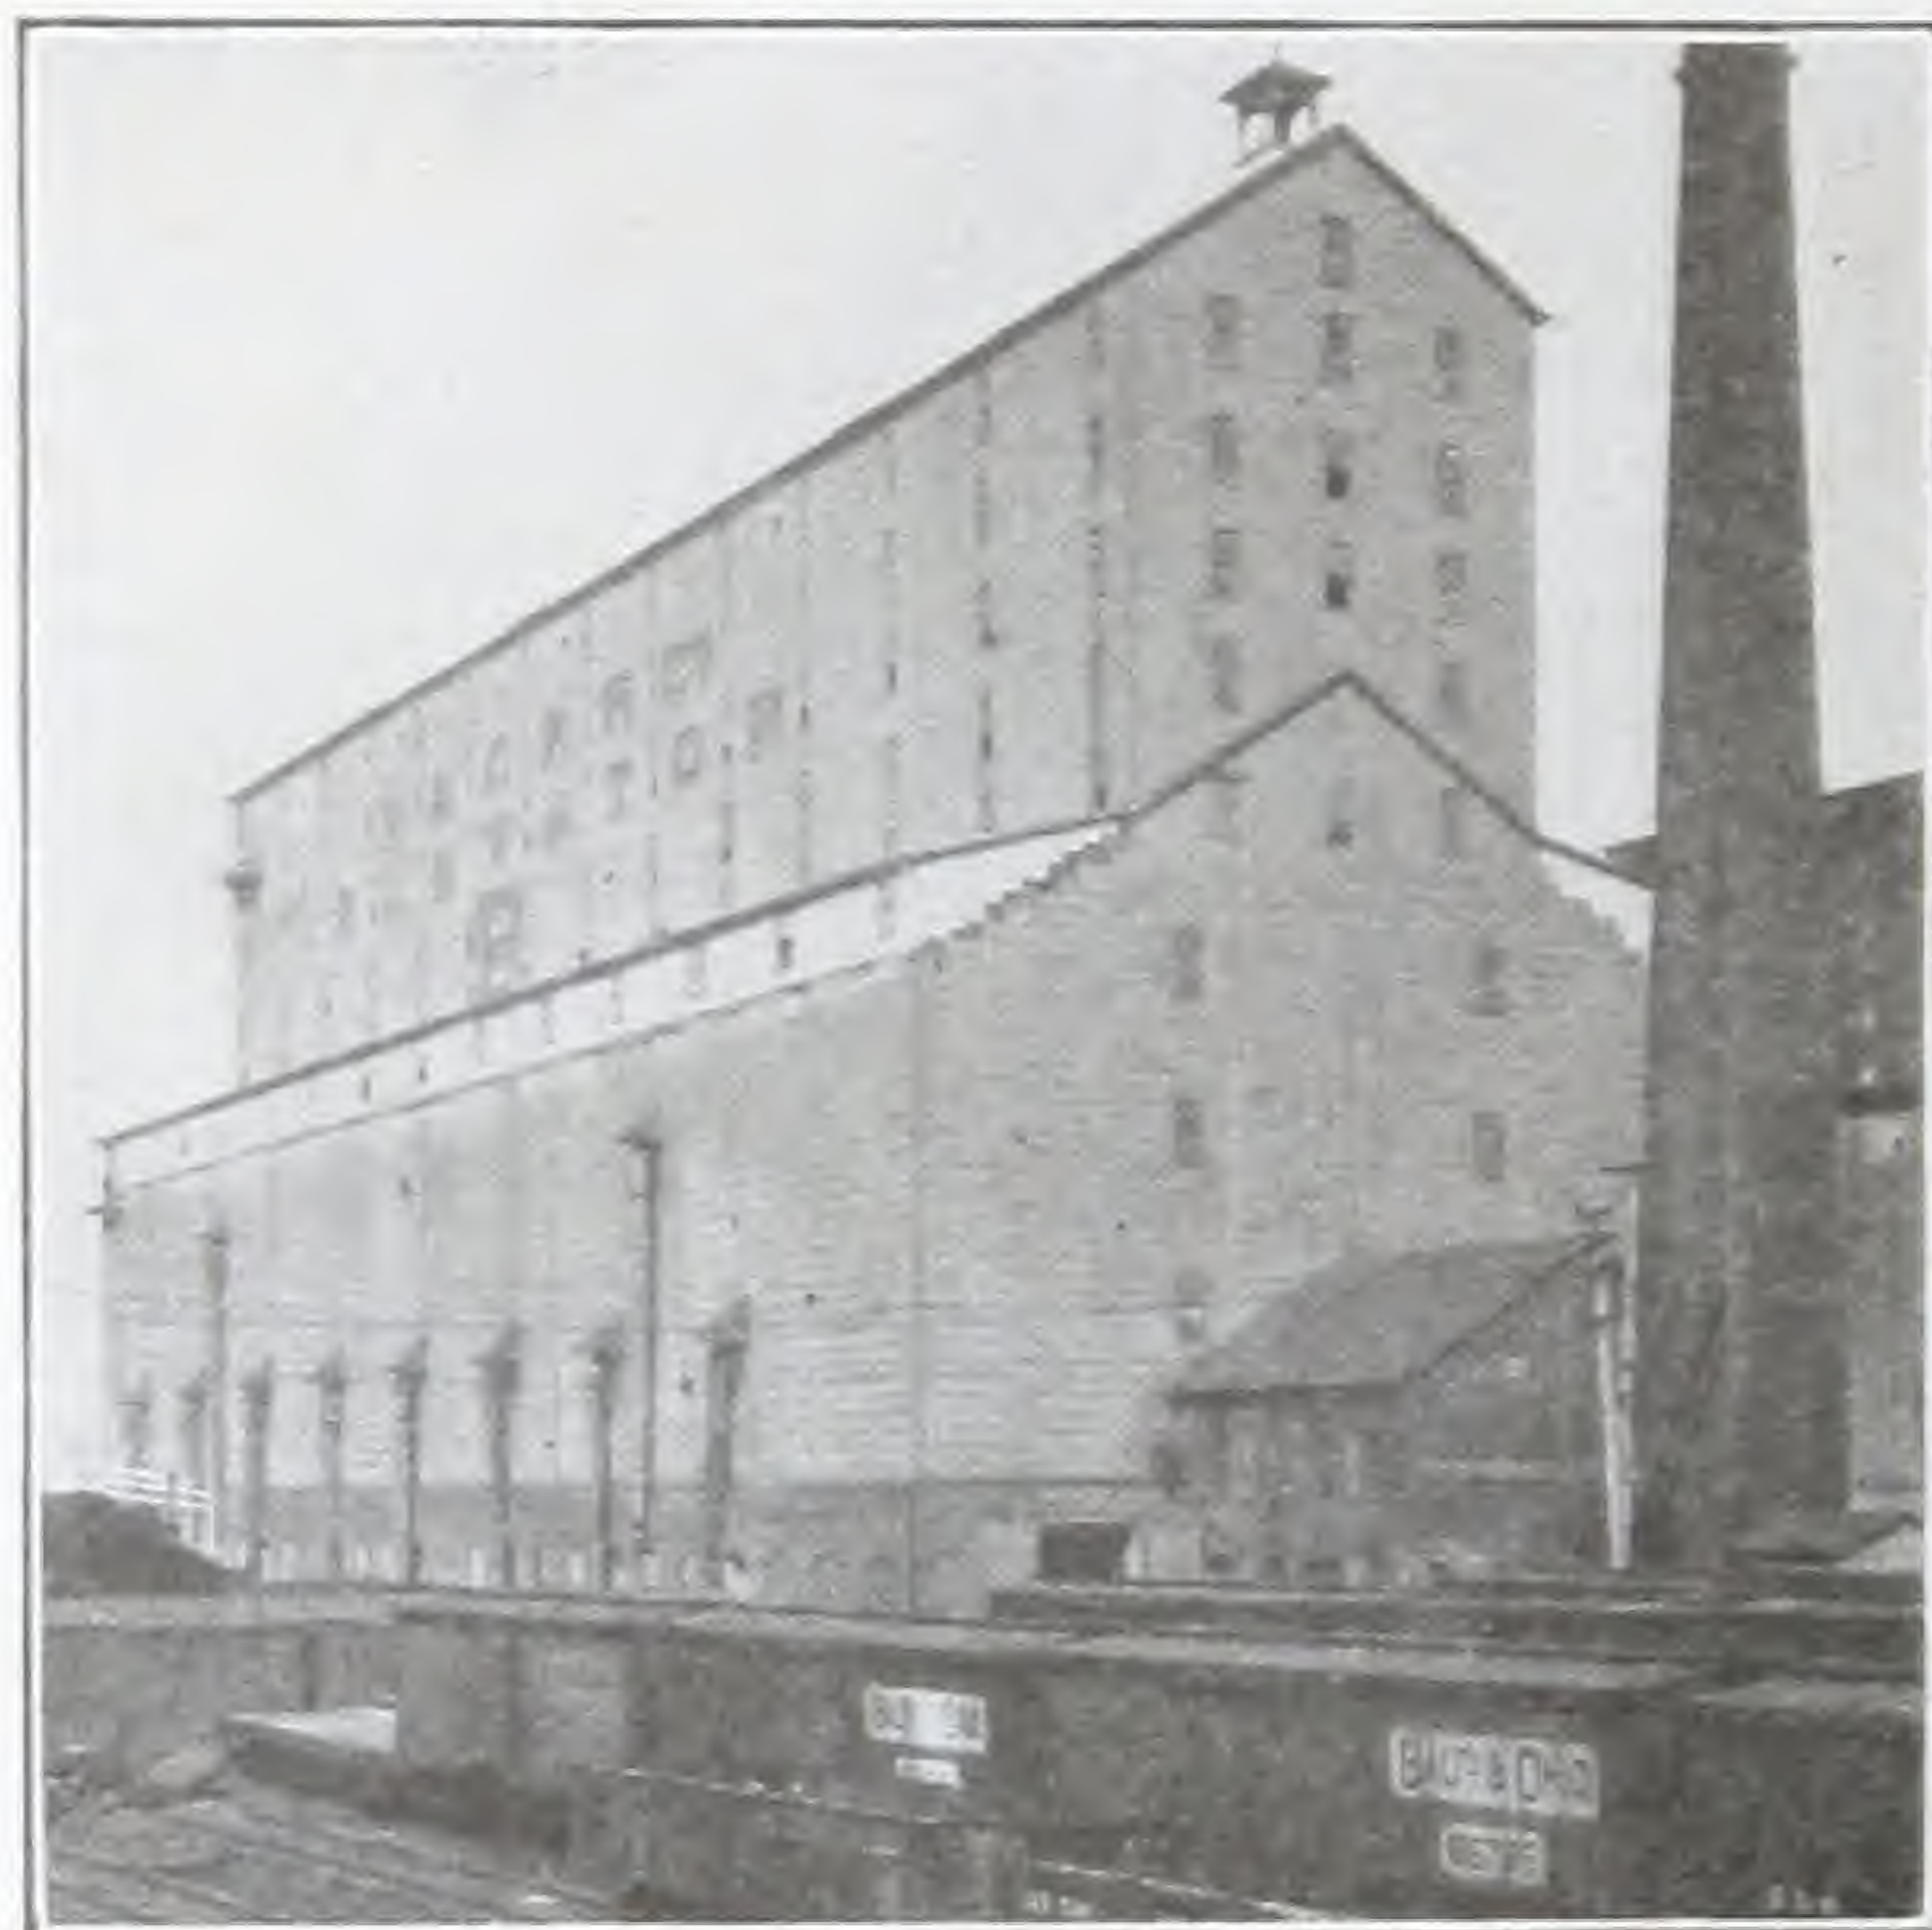
**50. NOTABLE TIN-ROOFING CONTRACTS:** Elevator B, of the Baltimore & Ohio Railroad Company at Locust Point, Md., roofed in March, 1909, with 180 squares of our Target-and-Arrow tin by George J. Laynor & Sons, Elk Ridge, Md.

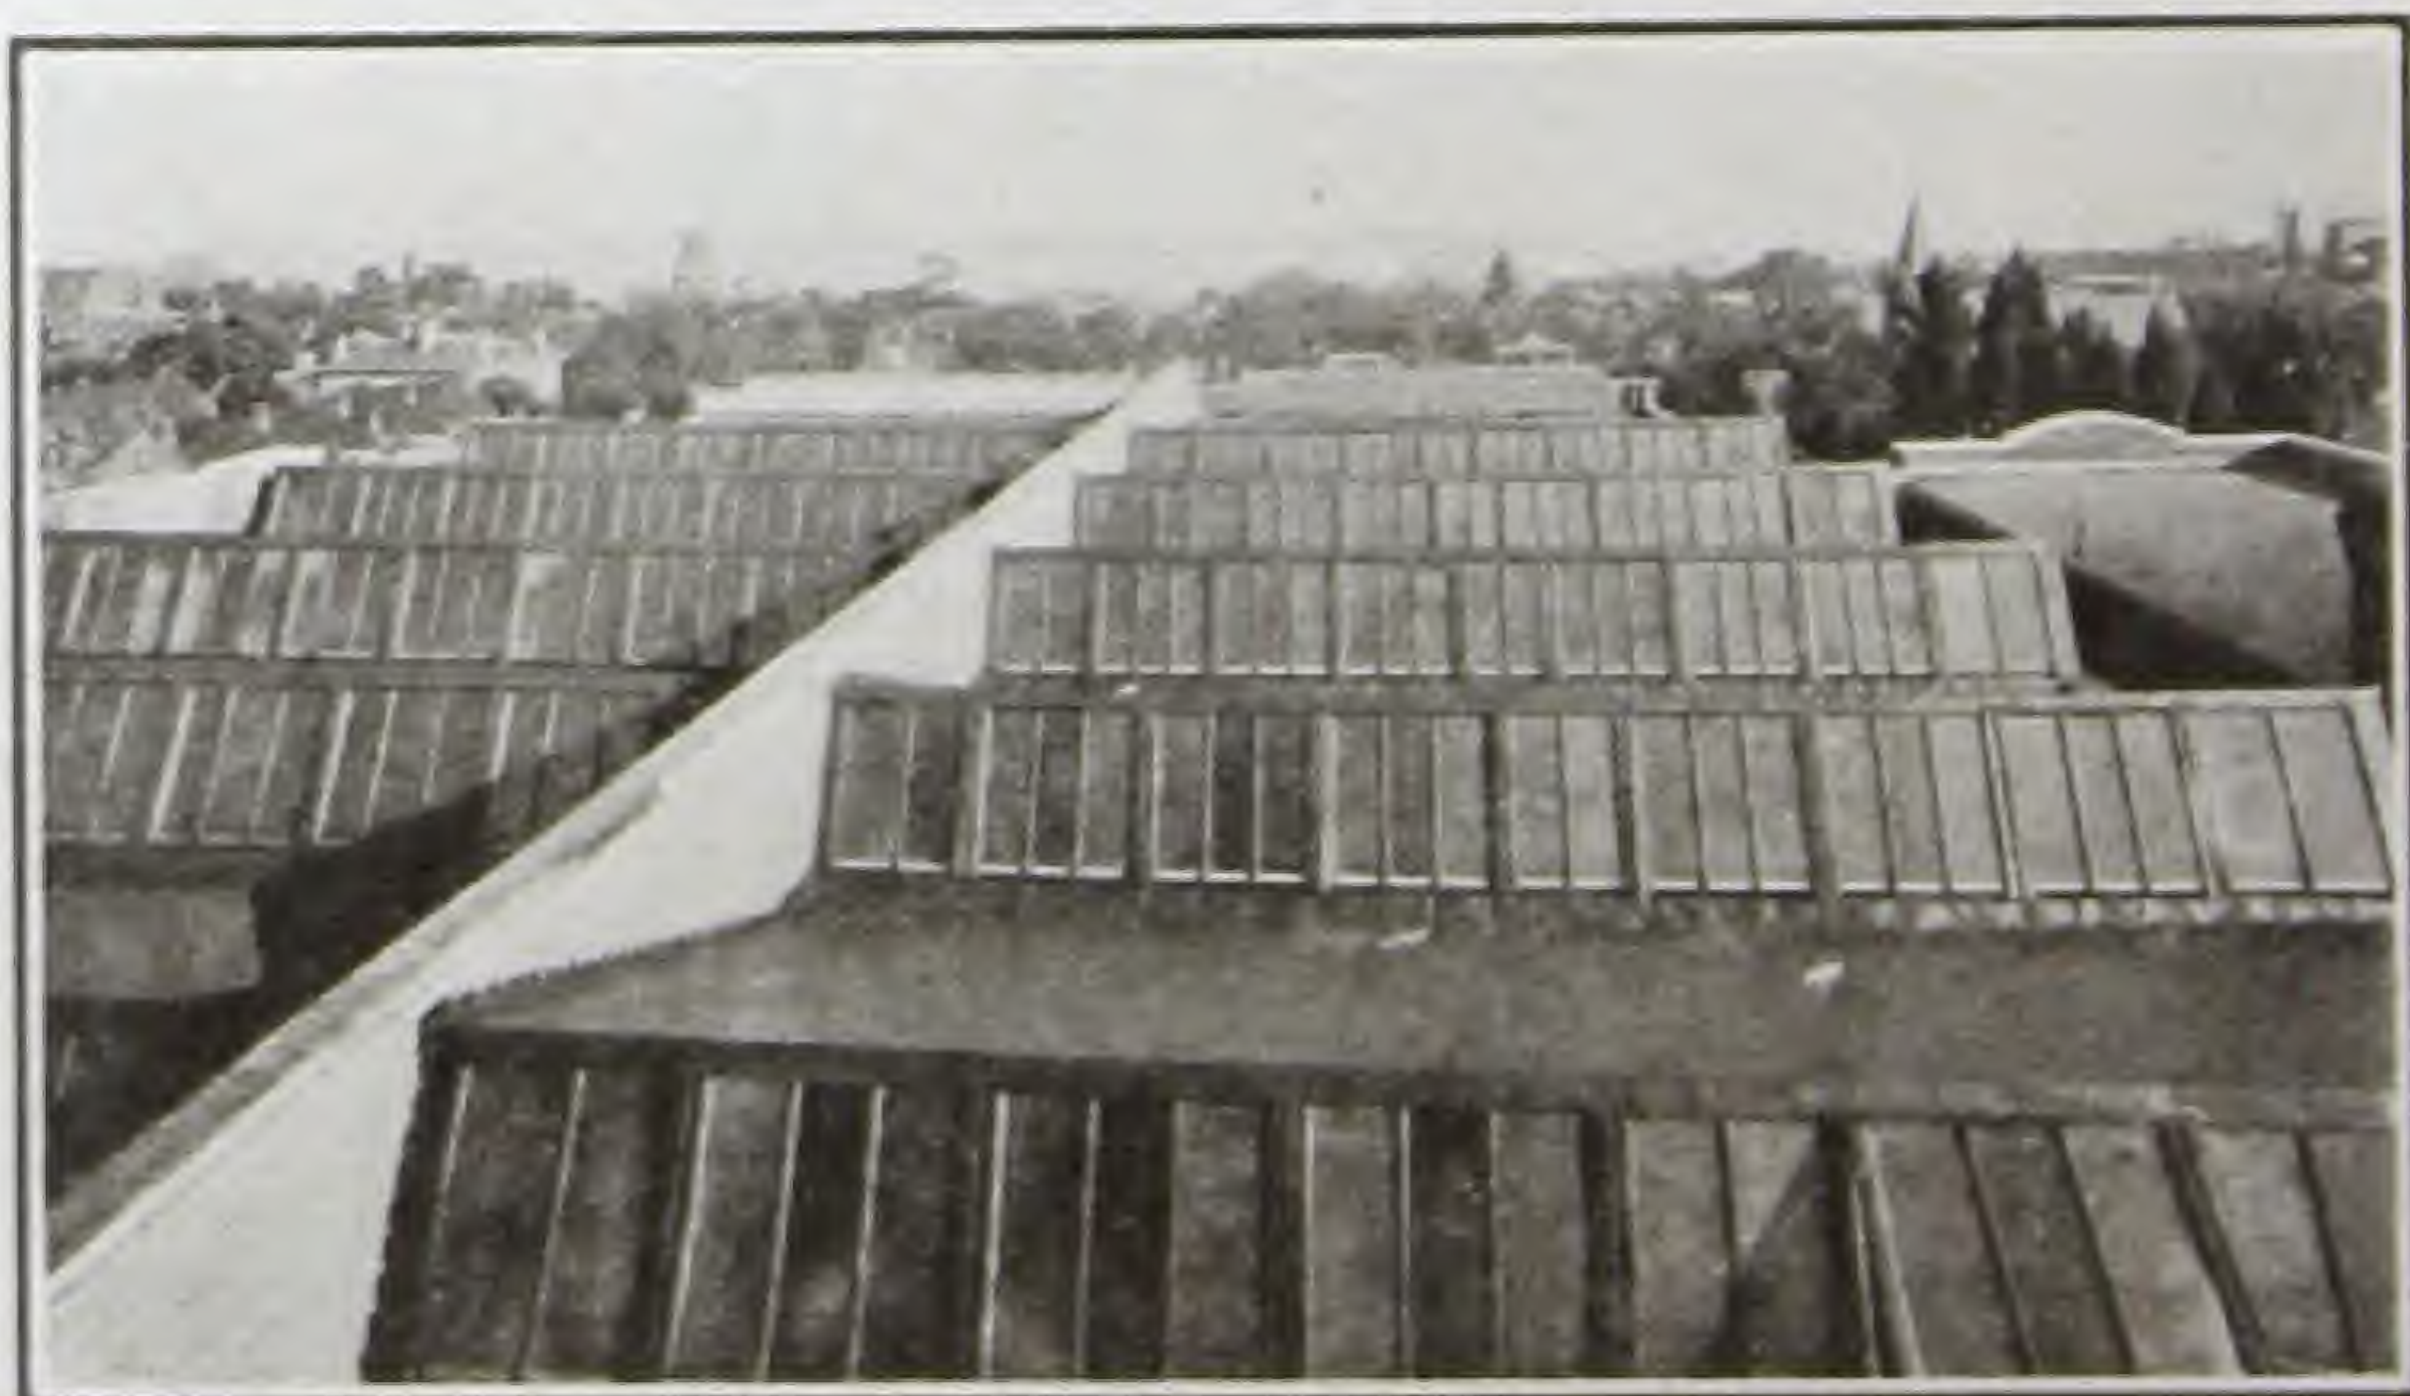
**51. NOTABLE TIN-ROOFING CONTRACTS:** Roof view, Canadian Kodak Company's buildings, Toronto, Canada. A good example of the highest type of factory roof construction, comprising wire glass set in metal frames for the skylights, and Target-and-Arrow tin for the flashings, gutters, and roof surfaces.
